**RESULTS OF A CULTURAL RESOURCES SURVEY  
OF THE AVERY LANDING RAIL YARD PROJECT AREA,  
SHOSHONE COUNTY, IDAHO**

July 2, 2012

**APPLIED ARCHAEOLOGICAL RESEARCH, INC. REPORT NO. 1095**

**RESULTS OF A CULTURAL RESOURCES SURVEY  
OF THE AVERY LANDING PROJECT AREA,  
SHOSHONE COUNTY, IDAHO**

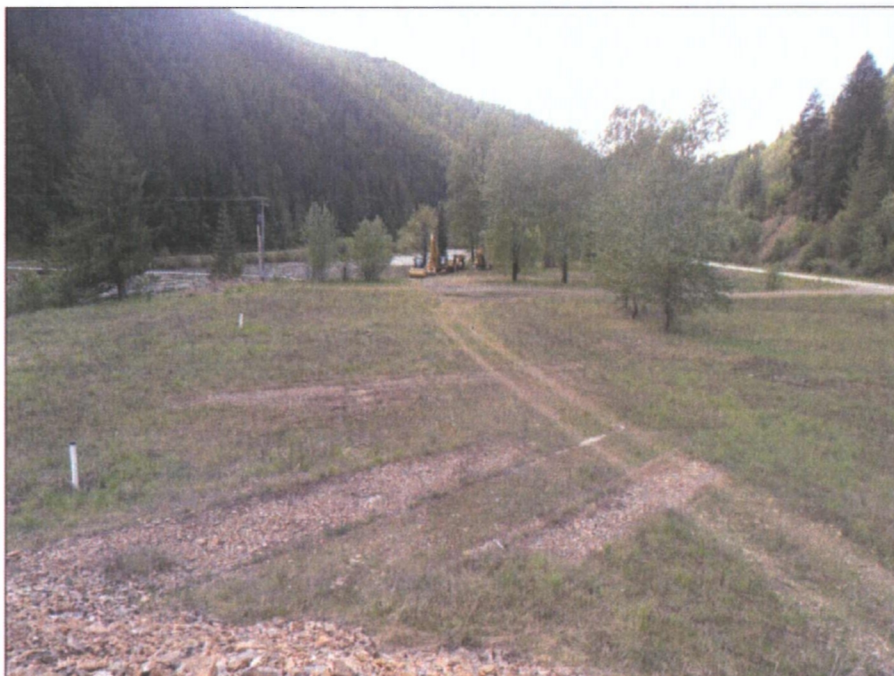
Figure 4. Overview of the Potlatch property within the project area. Photo is looking west from atop a large rock pile located on Potlatch property with the staging area in the background.

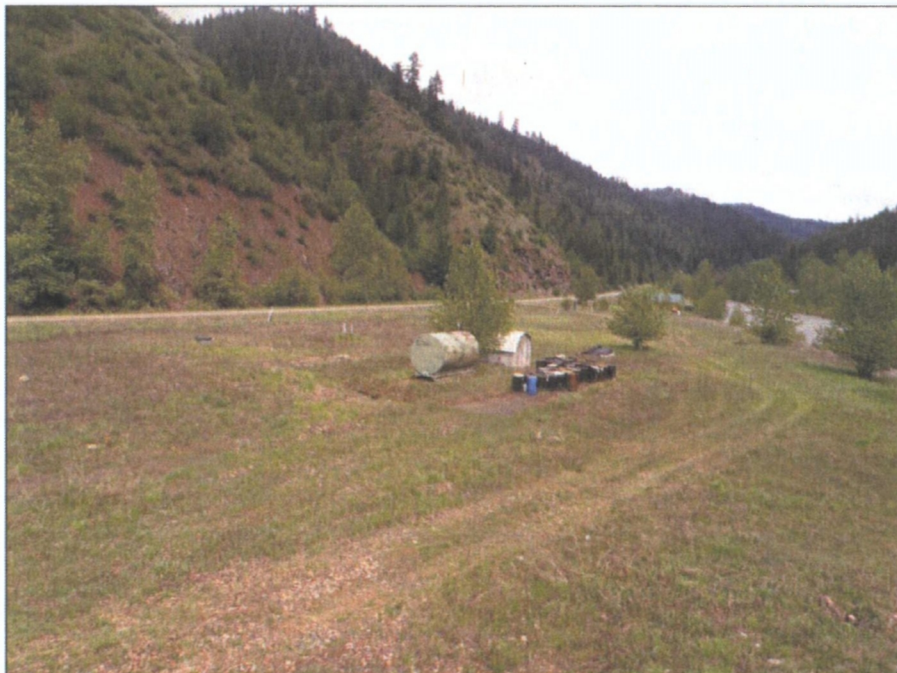
Figure 5. Overview of the main excavation zone in its current condition. A modern shed and storage container sit on top of a historic concrete pad (Feature 2, see below). View is to the northeast.

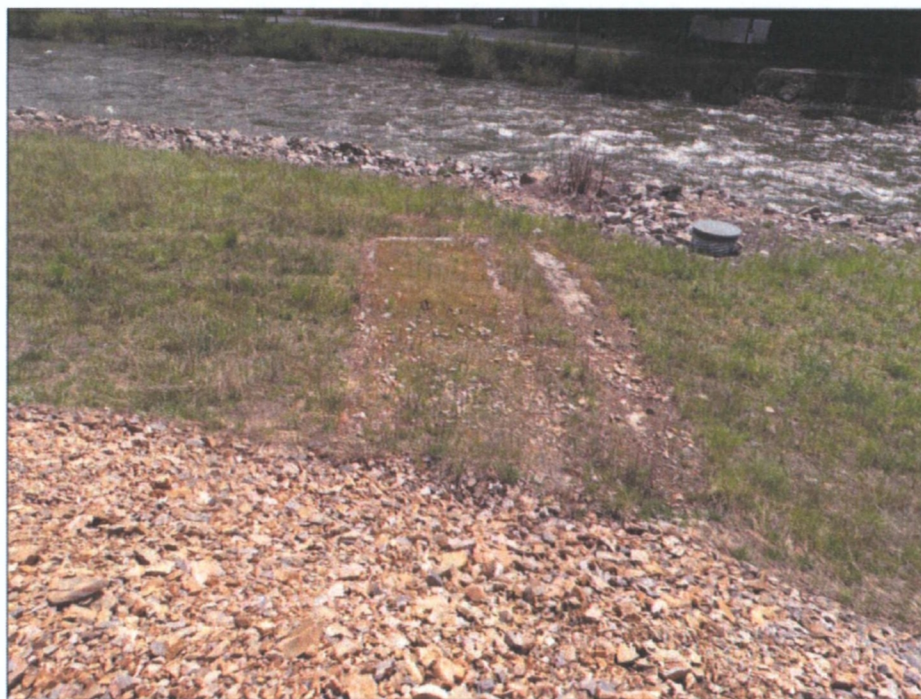
What likely is a concrete foundation was identified in the south-central part of the project area near the river bank and a short distance west of the section 15/16 boundary. According to the 1915 map, it is in the vicinity of the southeastern part of the roundhouse and very near where the map shows a storage bay within the roundhouse to have been located (Figures 8 and 9). It was likely part of one of the 12 bay stalls where locomotives were stored or maintained. The feature is composed of two disconnected pieces of concrete. The larger of the two is rectangular in outline and minimally 1 foot tall. It frames an interior space that was covered with grass and gravel. As observed it is 24 ft long and 8.5 ft across from outside edge to outside edge. The other part of the feature is a concrete footer or part of a foundation. It is 2 ft west of the first part. As observed it is 24 ft long and 3.25 ft wide. Both parts of Feature 1 extend northward and are covered by a large pile of rock. It is likely that Feature 5, described below, represents a continuation of Feature 1 on the north side of the rock pile. No artifacts were associated with Feature 1.

Figure 9. Photograph of Feature 1 looking southeast from atop the large rock pile located on Potlach property.

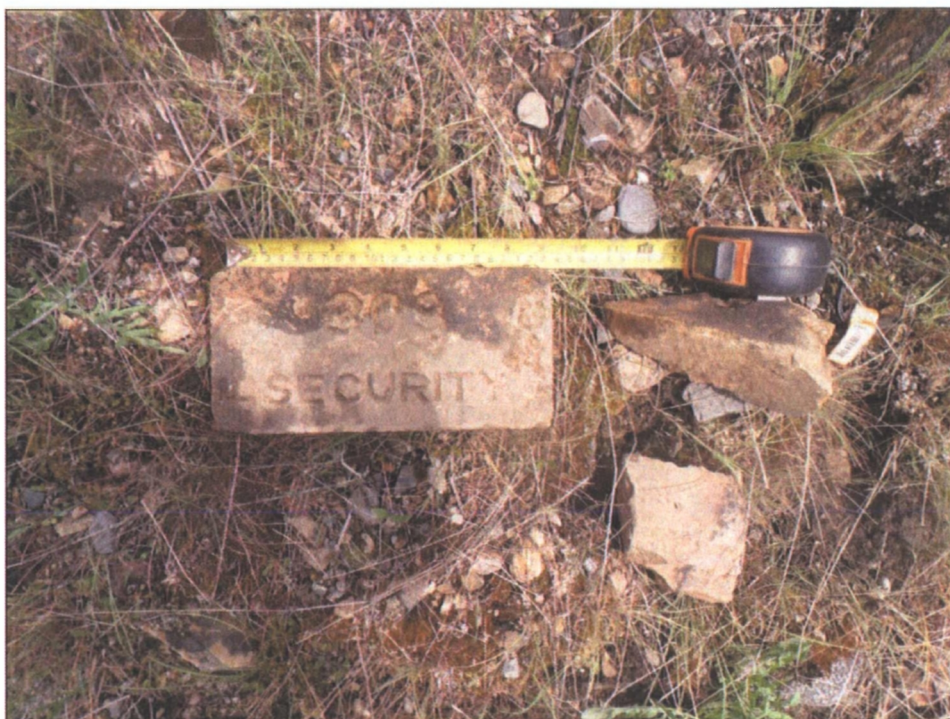
A concrete foundation and pad was observed at the eastern end of the Potlatch property just west of the section 15/16 line in an area that would have been in the center of the rail yard. It is 50 ft long east to west and 32 ft wide north to south (Figure 5). Its location and dimensions closely match those of the "Boiler House" depicted on the 1915 map (Figure 8). One complete brick was found next to the foundation/pad. The brick is machine made and tan in color. It is marked "309/SECURITY" (Figure 10). The mark identifies the brick as having been manufactured by the American Arch. Co. between 1910 and 1911 (Gurke 1987:294).

Figure 10. Close-up of brick recovered near Feature 2.

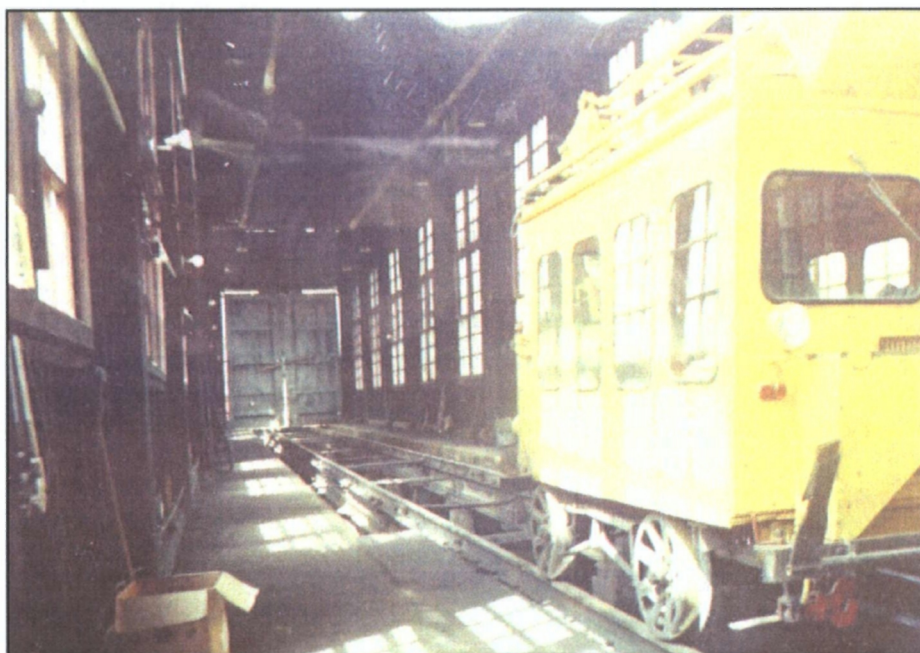
As shown in Figure 11 the inside of the roundhouse where trains were being stored in storage bays included tracks and a concrete floor very similar to the arrangement of Feature 3. Specifically, the feature consists of one 2-inch thick metal rail next to an approximate 12-foot wide concrete slab (Figure 12).

Figure 11. Photograph from the 1970s showing the interior of one of the storage bays in the roundhouse. Used courtesy of The Avery Museum.

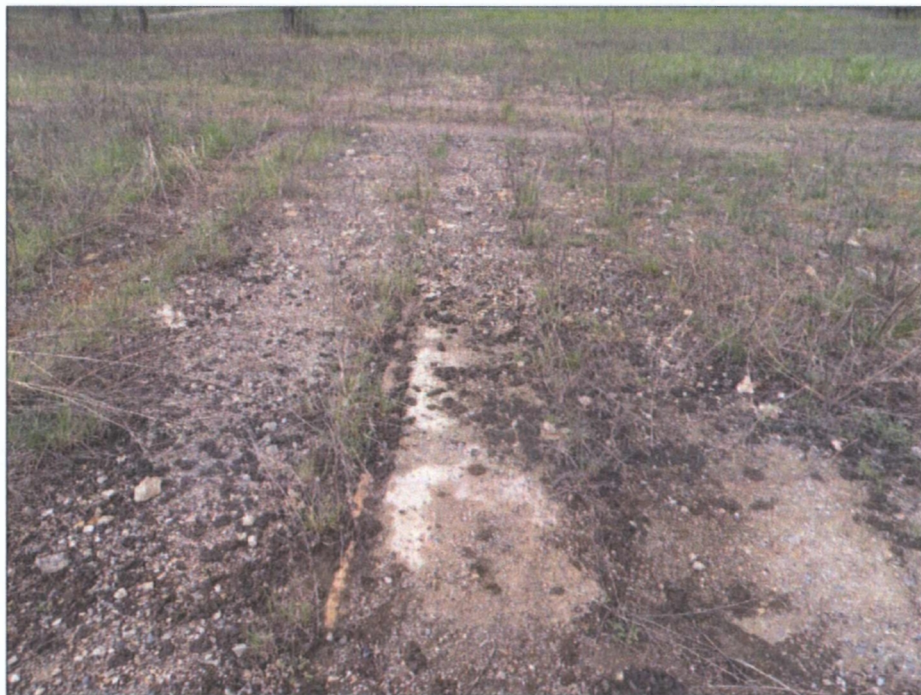
Metal railroad tracks laid in concrete were observed a short distance to the west of Feature 1 in the southern part of the project area. The location of the tracks corresponds well to where a storage bay and lead tracks are shown on the 1915 map (Figure 8). On the map the tracks are denoted to have been 129 ft, 1 inch long and connected the storage bay to the turntable. The observed section was approximately 15 ft long and 13 ft wide and would have been situated on the east side of the roundhouse.

Figure 12. View of Feature 3 that represents one set of lead tracks that were used to move locomotives and train cars between the turntable and the storage bays in the roundhouse. View is northwest.

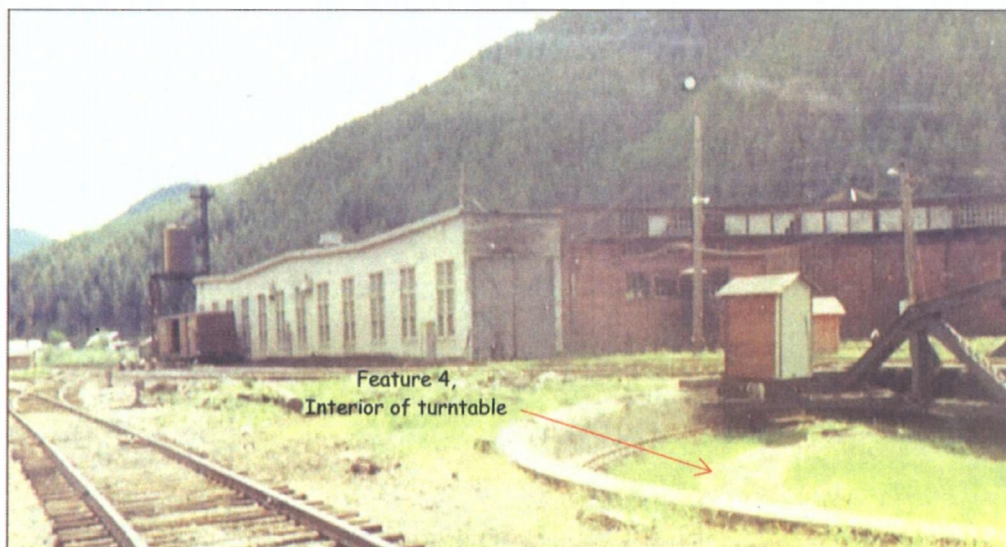
Figure 14. Photograph of the eastern portion of the turntable. Arrow is pointing at the interior concrete foundation of the turntable. Used courtesy of The Avery Museum.

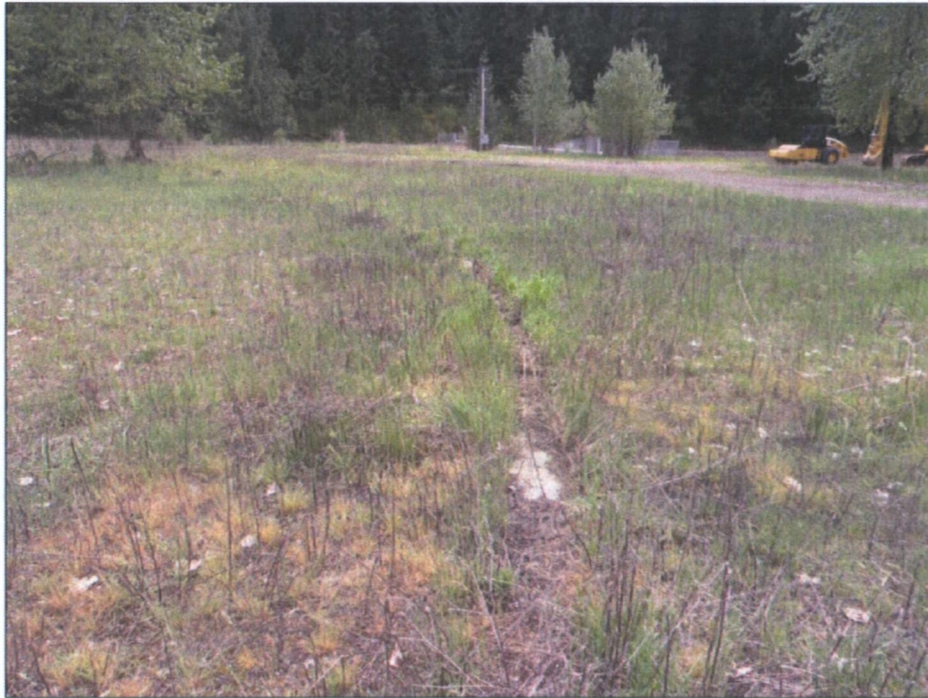
Feature 4 is located just south of Highway 50 in an area that would have been toward the center of the Avery Division rail yard (Figure 8). The feature is part of a circular concrete footer or foundation that represents an interior element of the railroad turntable that was used to move and position locomotives (and rail cars) between the main rail tracks to lead tracks that led into the roundhouse storage bays. Feature 3, described above, is an example of a lead track. The turntable was a large, round, concrete feature that was 107 ft in diameter and consisted of two tiers (Figure 8). Feature 4 is part of the interior, lower tier. Its function is unknown but it may have served as the surface upon which the turntable rotated (Figure 13). Feature 4 is approximately 20 ft long and 16 inches wide (Figure 14). Attempts to follow the arcing footer/foundation were unsuccessful and it may be buried beneath the ground surface. Following the arc of the exposed part led to several large pieces of concrete rubble that likely represent a demolished section of the turntable (Figure 15).

Figure 15. Feature 4, concrete foundation of the interior section of the turntable.  
View is to the south.

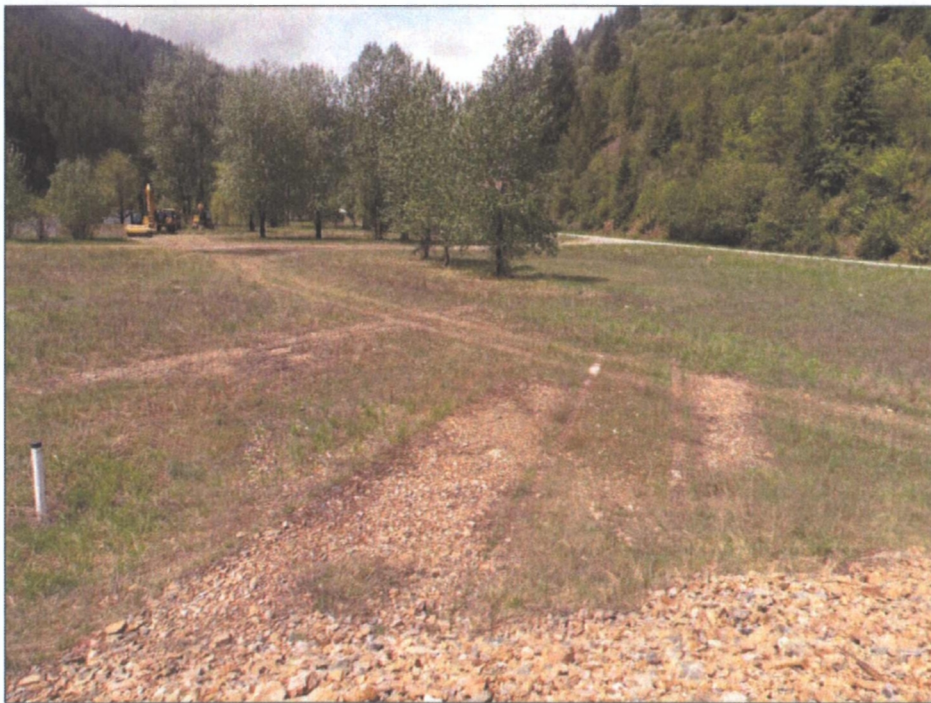
Feature 5 consists of a section of lead tracks that would have been between the turntable and the roundhouse or partly within the roundhouse. The tracks are marked by two parallel indentations on the ground surface where rail track has been removed surrounded by concrete. Another set of lead tracks, Feature 3, oriented parallel to Feature 5, are located just to the west (Figure 16). Feature 5 is 40 ft long and 5 ft wide. It extends southeastward to a large rock pile. Feature 1 is in line with it and the two features appear to represent most of the length of a single set of lead tracks.

Figure 16. Feature 5, concrete floor and lead track lines. Another set of lead track,  
Feature 3, can be seen to frame left. View is northwest.

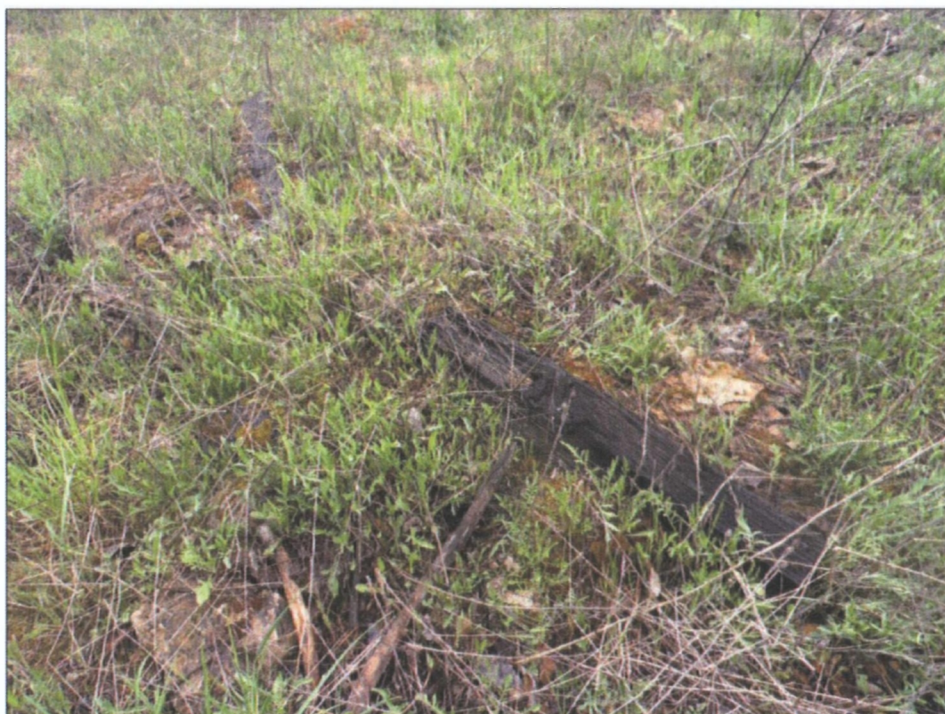
Located in the easternmost part of the project area within the Bencik property at the top edge of the river bank this scatter of modern and historical debris included a corroded wire, two wooden railroad ties, one concrete fragment, milled wood, and three pieces of modern bottle glass (Figure 17). Items identifiable as more than 50 years were mixed together with objects of undeterminable age and items that were modern. These historical items comprise a historic-period archaeological scatter. They were observed scattered in an area measuring approximately 100 ft east to west and 20 ft wide north to south. Materials included items of architectural character and more specifically were attributed to the Avery rail yard deconstruction.

Figure 17. Photo of Scatter 1 located in the easternmost part of the project area.

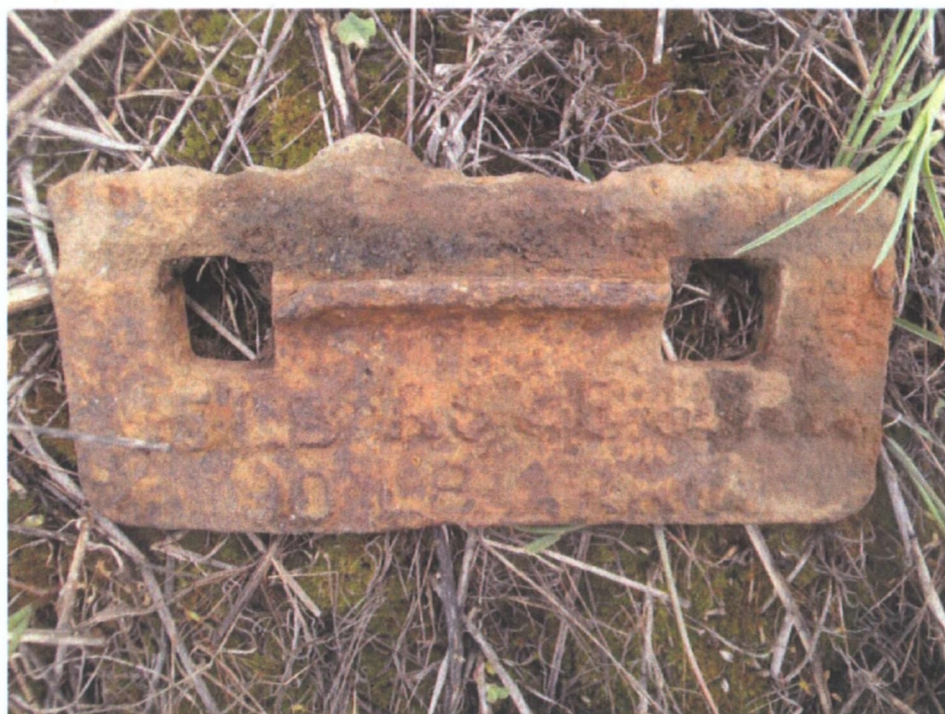
The historic-era scatter is situated on level terrain, just south of Highway 50 within the Bencik property. It consists of a sparse scatter of domestic and architectural debris over an area of 150 ft by 100 ft. Artifacts noted include one aqua piece of bottle glass, one undecorated ceramic bowl fragment, four railroad-related metal items, several pieces of terra cotta sewer pipe, and two slabs of concrete. The only noteworthy artifact was a metal railroad plate that was marked with "55 LB AS\_E & RR/90 LB ARA A" (Figure 18).

Figure 18. Railroad-related artifact found within Scatter 3.

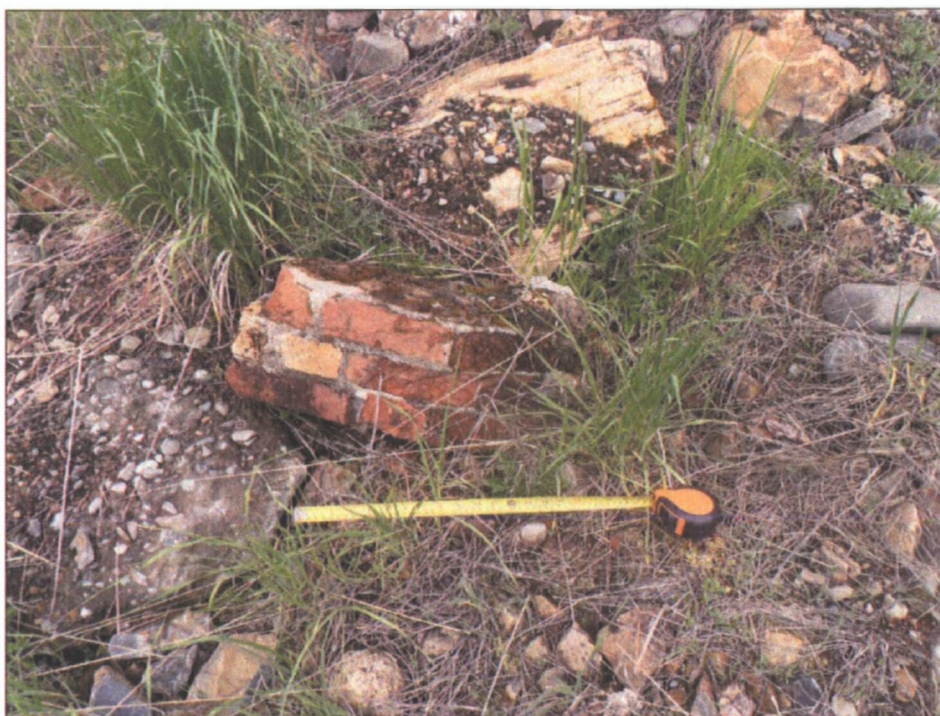
Scatter 4 is located on the Potlatch property immediately west of Feature 2 and extends approximately 140 ft long and by 40 ft wide. The scatter consists of two pieces of aqua bottle glass, about 12 whole bricks (both red and tan), several bricks attached together with mortar, and large concrete pieces (Figure 19). No maker's marks or other diagnostic indicators were observed. The debris is mostly architectural and likely related to demolition of the roundhouse and associated buildings of the rail yard.

Figure 19. Structural debris included in Scatter 4.

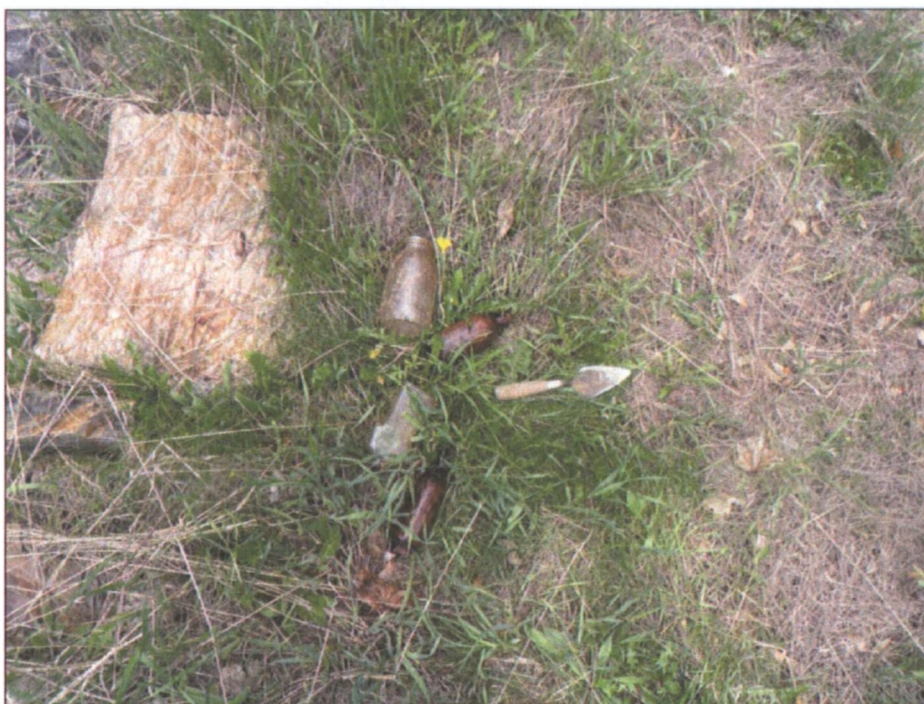
The historic scatter is mostly domestic in character and located on the western end of the project area, next to the bank. Artifacts noted include four historic bottles arranged closely together (Figure 20) and one train railcar wheel (Figure 21). The train wheel is 17 inches in diameter, made of metal, and is located 10 ft north of the bottles. Two of the bottles were amber glass while the other two are colorless glass bottles that show no hint of amethyst coloring (indicative of the use of manganese dioxide as a decoloring agent in the glass, which if present would date the bottles to ca. 1880-1925 [Newman 1970]). Two of the glass containers are embossed on the base with the oval-diamond-I trademark for the Owens-Illinois Glass Company (Toulouse 1971:403) and two are embossed on the base with a connected "NW" for the Northwestern Glass Company.

Figure 20. Bottles included in Scatter 5. Trowel points north.

Four of the artifacts provide dates of manufacture for the Scatter 5 assemblage (see Table 1). The Northwestern Glass Company used the connected “NW” trademark since 1931 (Toulouse 1971:390), while the oval-diamond-I trademark for the Owens-Illinois Glass Company was in use from 1929 to 1954 (Toulouse 1971:403). The number “7” appears to the right of the trademark on the Owens-Illinois flask, in the place where, according to Toulouse (1971) and Lockhart (2010), the year of manufacture should be located. It is likely that this single digit number represents 1937 because after 1940, the use of double digits began (Bill Lockhart, personal communication to Jessica Hale, May 1, 2010). The other Owens-Illinois container is a beer bottle and is embossed on the base with the number “47” to the right, which undoubtedly represents 1947.

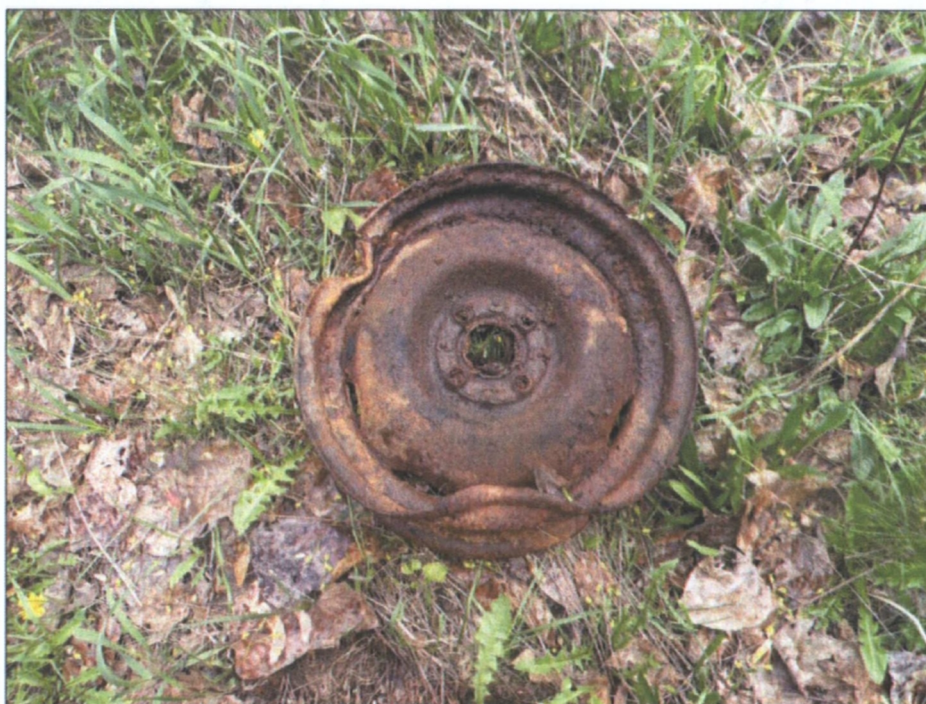
Figure 21. Train wheel included in Scatter 5.

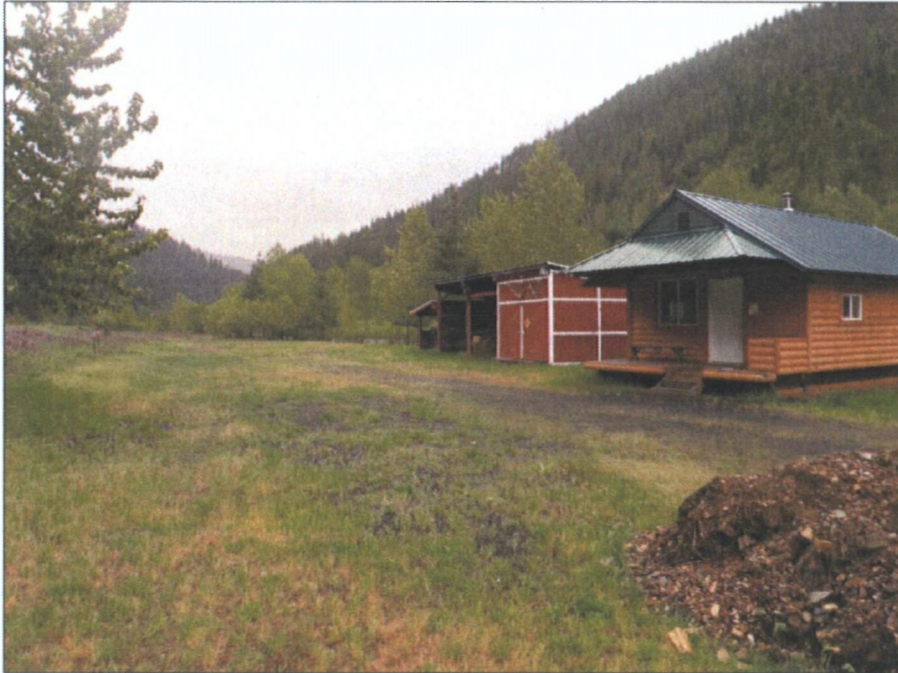
Figure 4. Overview of the Bentcik property within the project area. View is to the southeast.

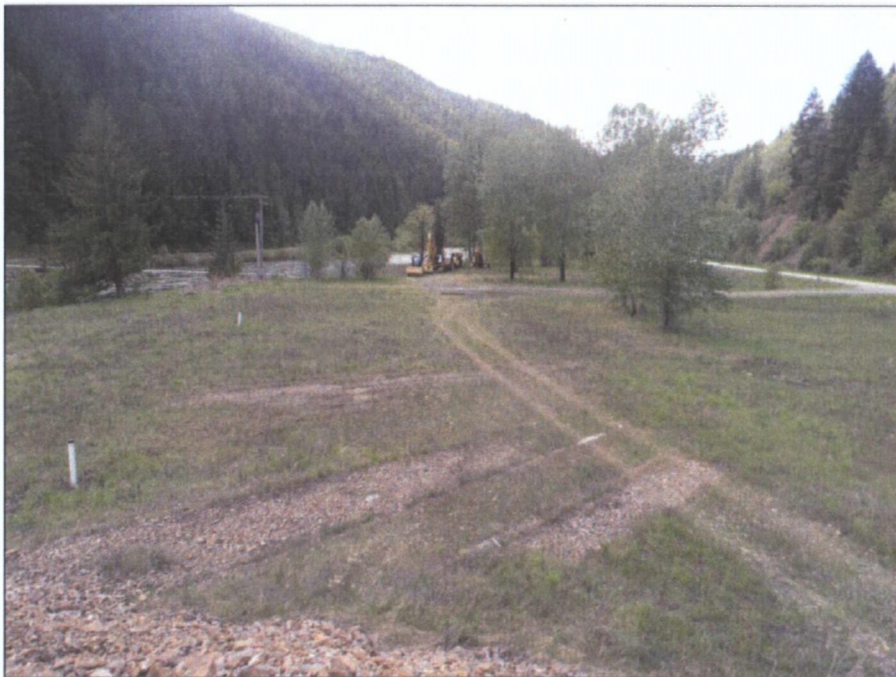
Figure 5. Overview of the Potlatch property within the project area. Photo is looking west from atop a large rock pile located on Potlatch property with the staging area in the background.
